Appendix

Stormwater Management Plan: Inventories

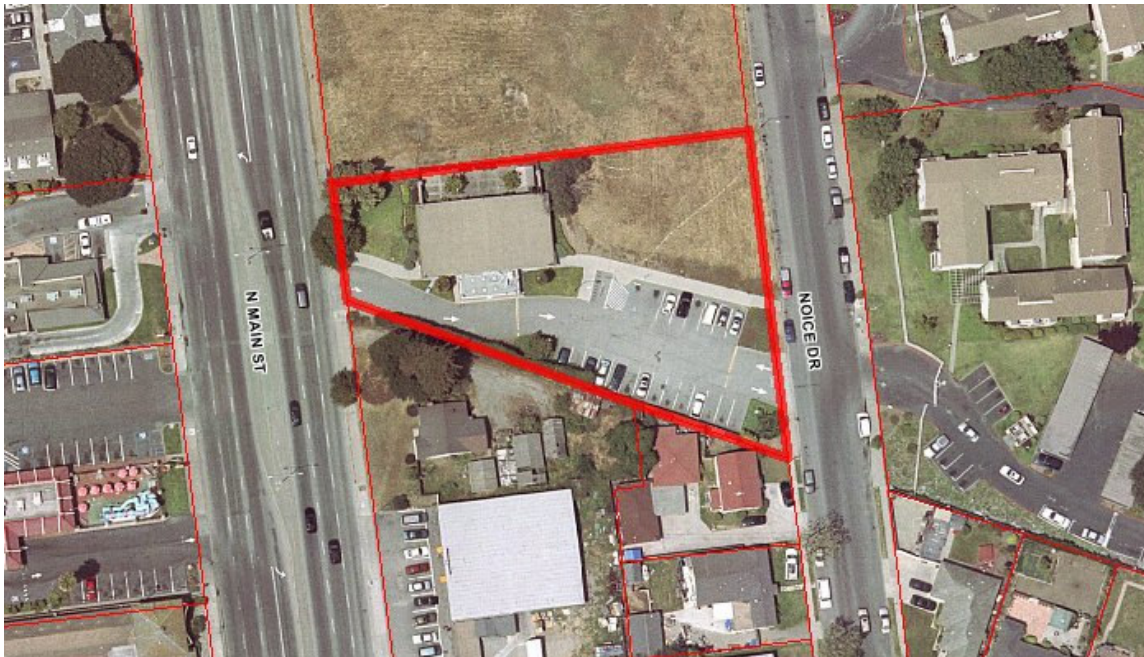
Current park and facility maintenance procedures, as described in BMPs SC-10, 11, 34, 41, 43, 60, 71, 73, and 75 are effective in controlling pollutants except in the parking lots where runoff flows to unprotected street drains. Litter and garbage are picked up daily in parking lots, landscape debris such as leaf matter are raked several times a year, and spills or hazardous vehicle waste products are removed when observed, however regular and thorough cleaning of the parking lots is not possible with available staff and resources.

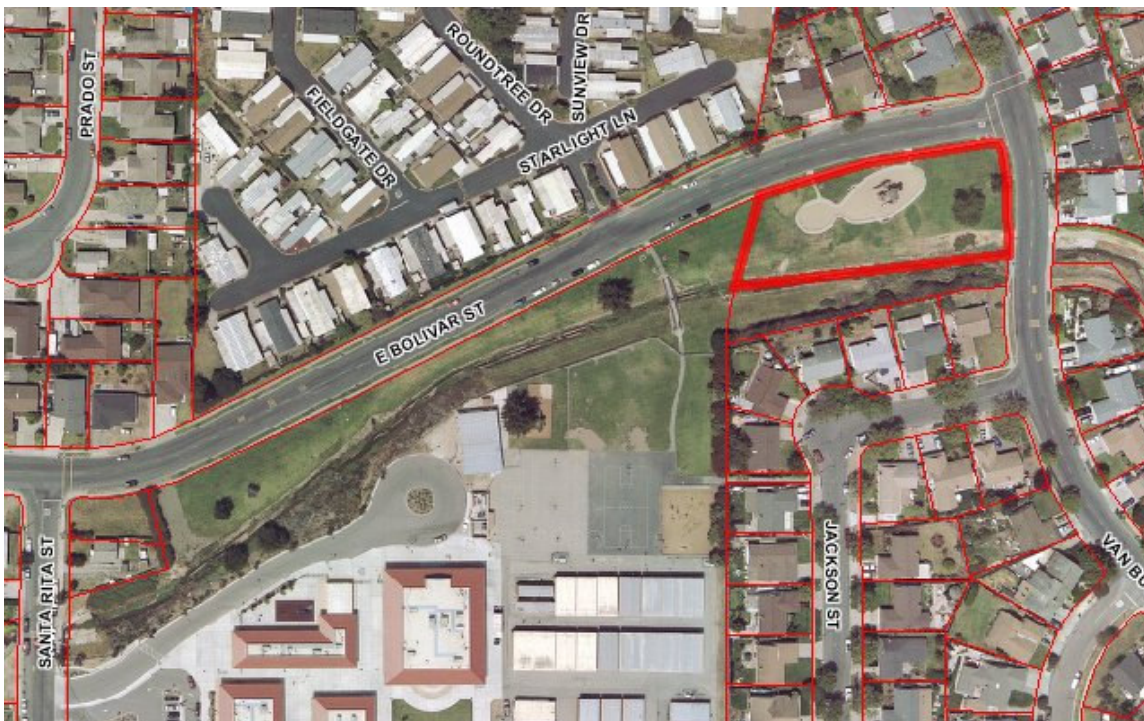
The original channel was a swale with plants and turf that graded directly to the concrete bottom in a smooth, continuous transition. This has been eroded by many high flow winter storms over several years, creating raised edges of deposited silt and eroding channels on both sides of the concrete bottom. Several culverts carry nearby street and road drainage directly into the creek. See Wastewater and Street Section reports for further, specific, information on creek maintenance concerns, BMPs, and recommendations, including the erosion issues in the swale bottom. Other potential site pollutants are sediment, nutrients, trash, metals, bacteria, oil & grease, organics, pesticides, and oxygen demanding substances. These materials result from building, grounds, and landscape maintenance operations, use of the park facilities for recreational activity, and inflow from street drains. The creek also receives runoff from asphalt play surfaces on the adjacent school site, which flow into drains at the south side

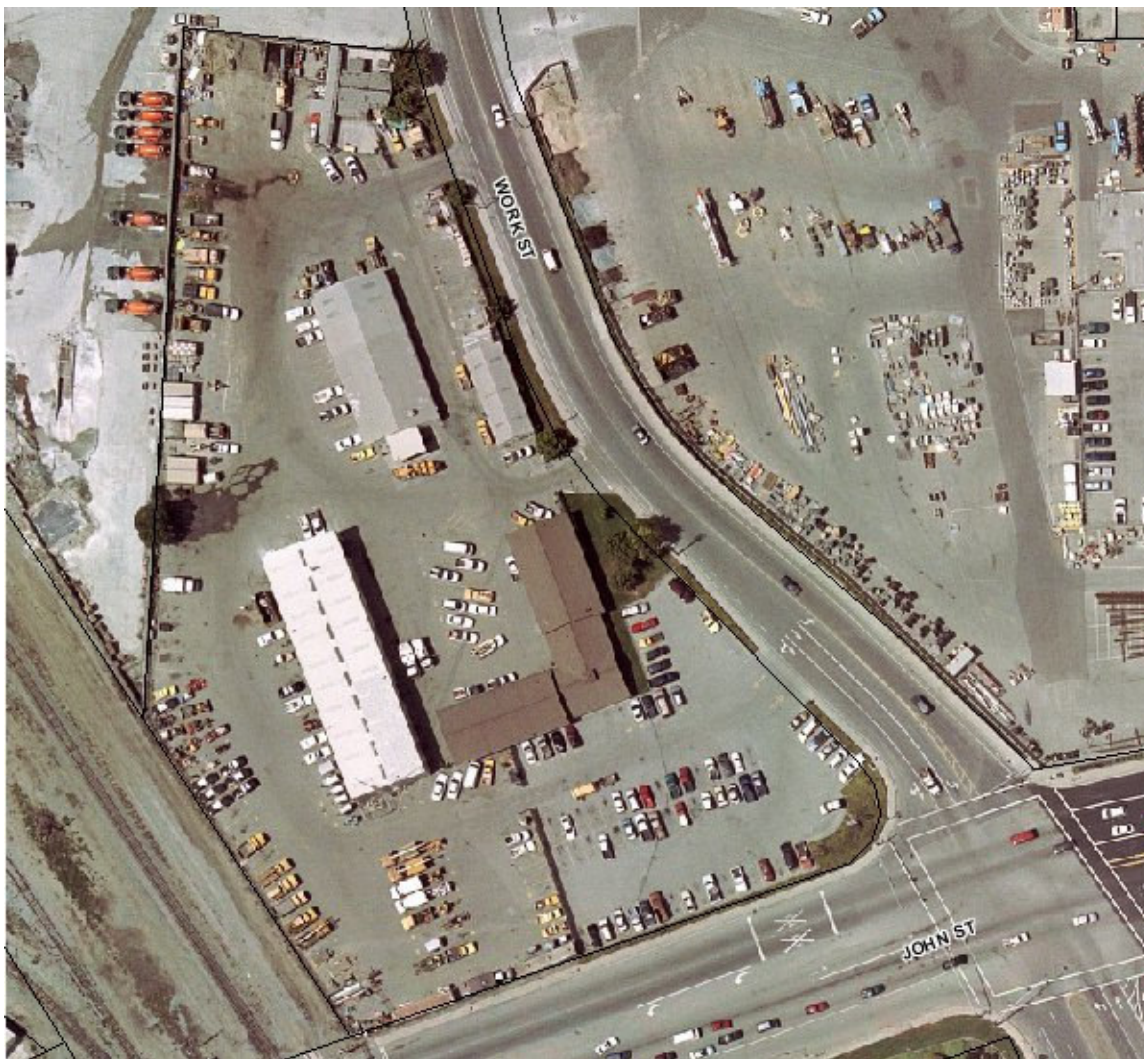
Due to the large number of vehicles housed and driven in and out of the Yard, vehicle generated pollution is a prime concern. Another prime concern is the present condition and design of the Yard itself. As parking is distributed over of the site, potential contaminates are distributed throughout the Yard. Employee parking at the front of the site, as well as city vehicles housed throughout the site have the potential to send contaminates downstream. Vehicle and equipment washing represents another potential source of contamination. The Yard's vehicle wash bay represents a more localized potential. The storm drain that services the yard does not have an adequate filtering system to prevent pollutants from entering downstream water bodies. Further, the decrepit condition of the asphalt paving and its constant degradation is resulting in asphalt gravel and chunks being discharged into the water system.

In addition to the pollutants of concern generated by activities at the Yard, the general poor condition of the Yard itself is a concern. The Yard's condition reflects the City's strained economic condition. Buildings are not in great repair, and the poor condition of the asphalt paving throughout the rear 2/3 of the site poses concerns. In many places asphalt paving is severely cracked, and along traffic lanes it is breaking into pieces of various sizes. Rainwater can wash these particles to the nearest catch basin and downstream.

With quality of water runoff an outstanding concern due to treatment limitations and the decrepit condition of the pavement, the City poses to make improvements at the Yard. In the winter of 2005, the City will install a new storm drain system at the Yard. This will include a series of oil/sand/water separators. Further, a new catch basin nearest the wash bay will direct water runoff into the sanitary sewer system rather than the storm drain as is the case now. The City is planning to replace broken asphalt and repave damaged pavement. This project is projected to cost approximately \$419,000 and be
